ENGINEERING REPORT
RED LIGHT RUNNING TRAFFIC MONITORING
SYSTEM

State Route 99/ Pacific Highway at SR 516/S Kent-Des Moines Rd
Des Moines, WA

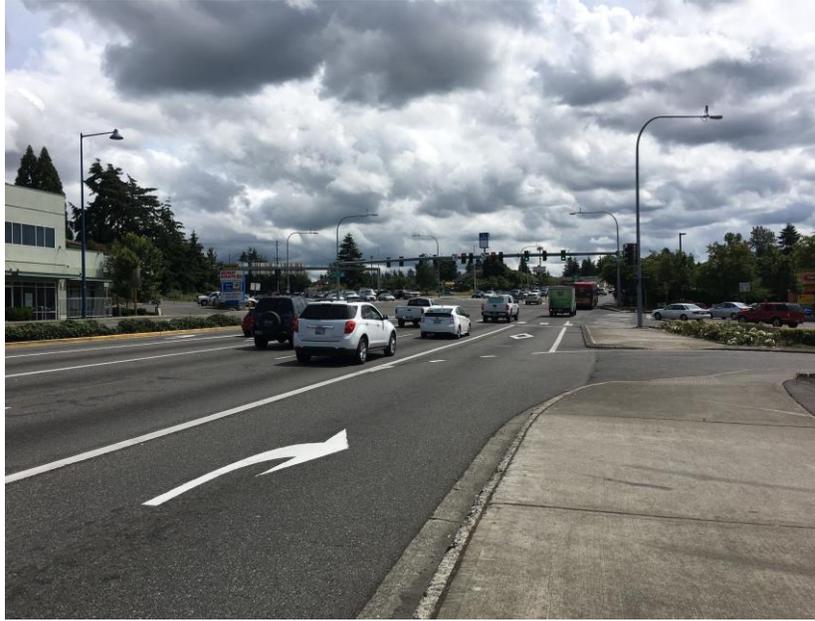
Figure 2: Southbound approach, looking south

There are no visual obstructions to the signal heads on the southbound direction of SR 99 and the signal heads on the westbound direction of S Kent-Des Moines Rd. The Longitudinal grades are relatively flat on both approaches. The visibility to the signal meets the required MUTCD standards (Table 4D.12/ Section 4D.12)
